Potlatch Corporation  
Resource Management Group  
Idaho Region

RE: Avery Landing Remediation

Subject: Avery Landing

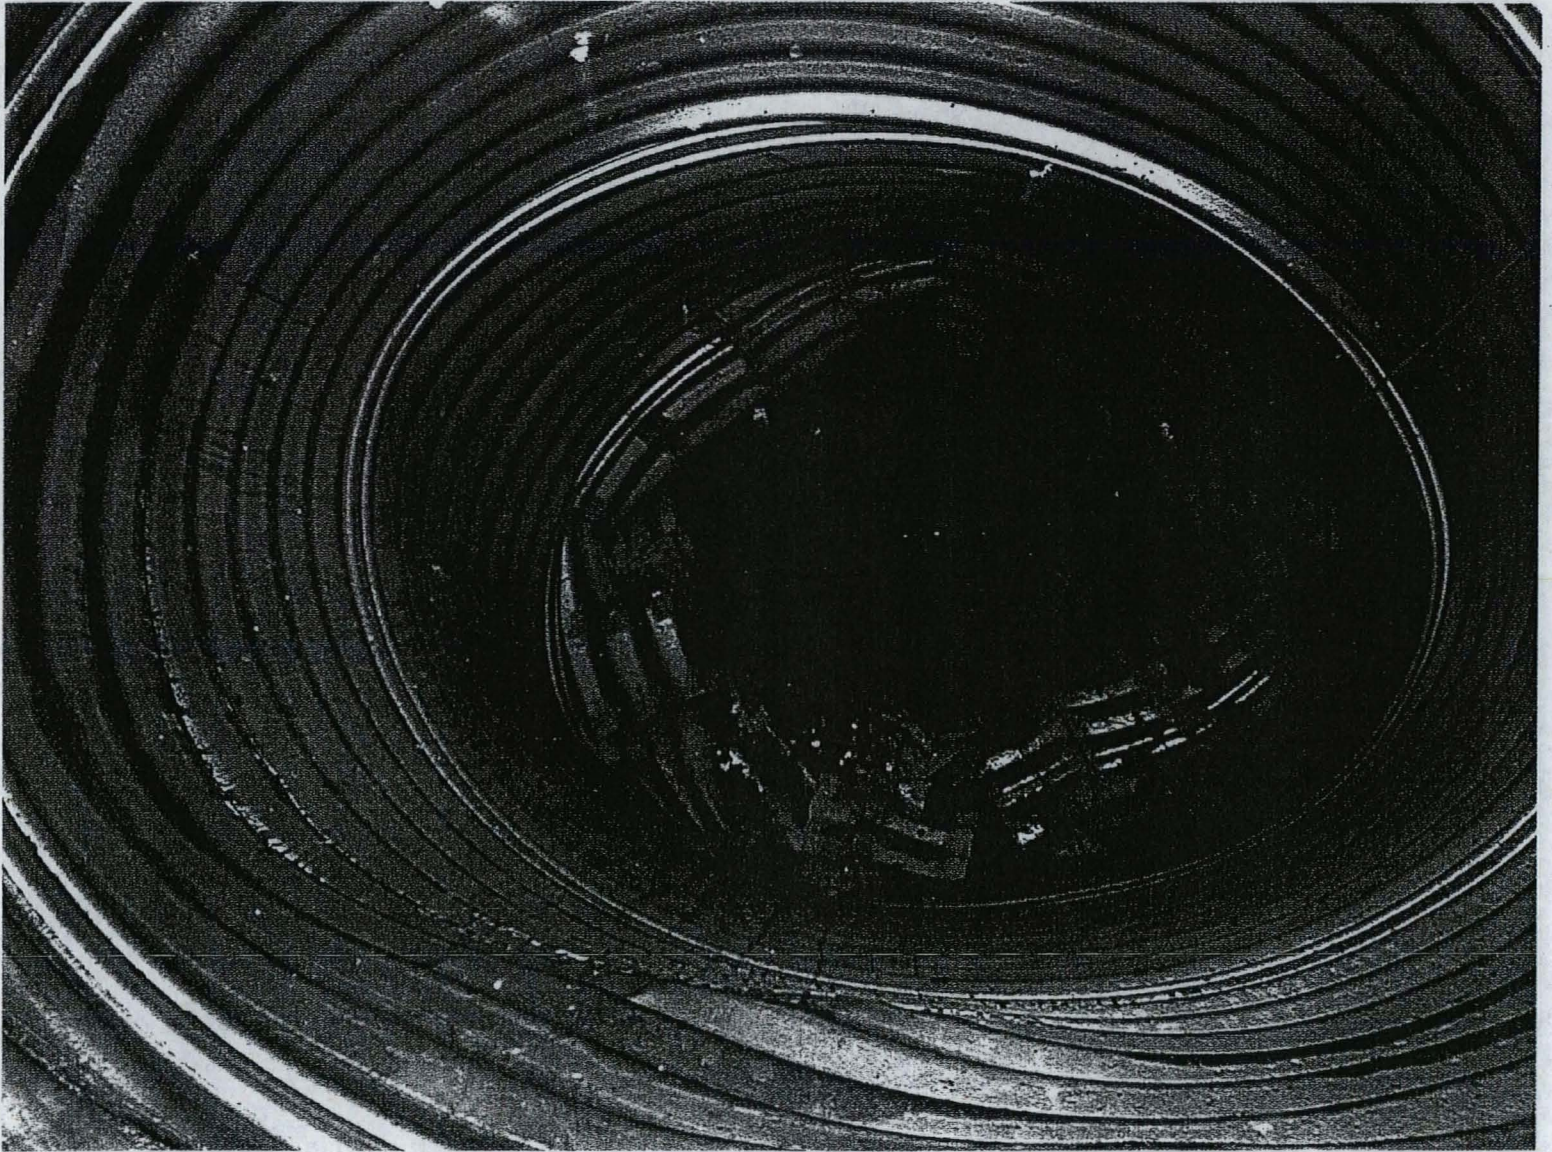
11/08/2000

Looking down recovery well CWS  
Sides caved in significantly approx 5' down

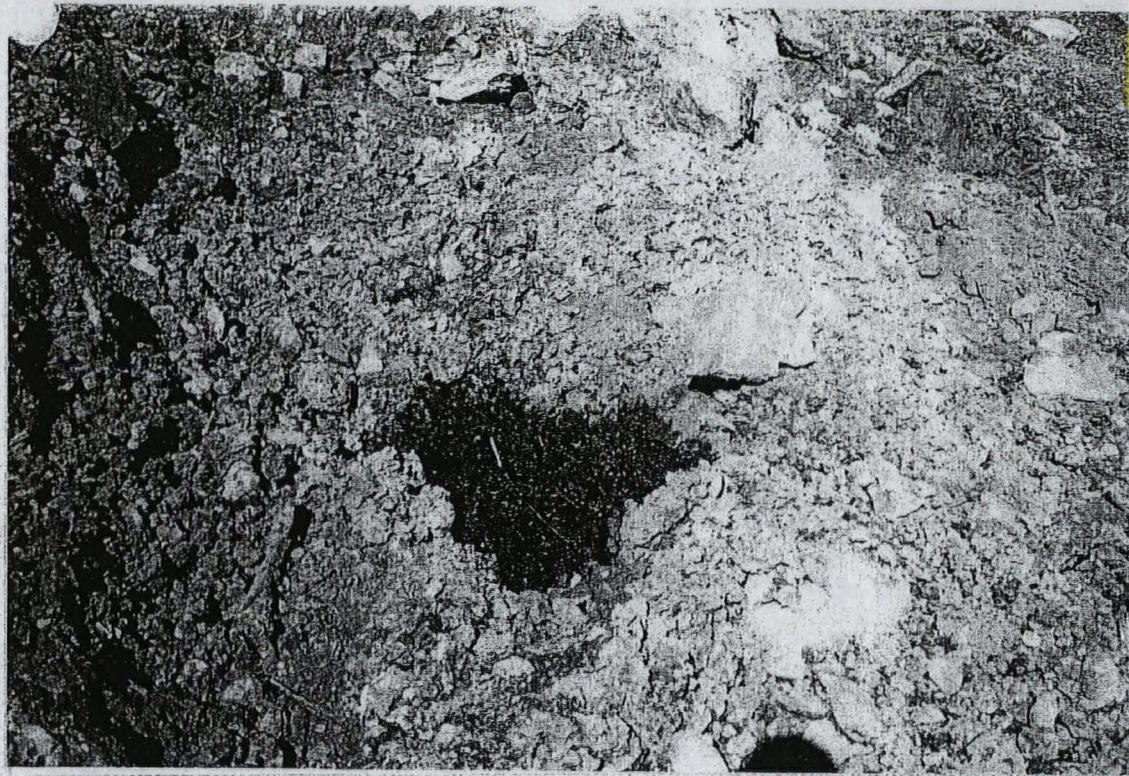
Photo of the inside of the portable  
O/W separator petroleum film evident  
KB

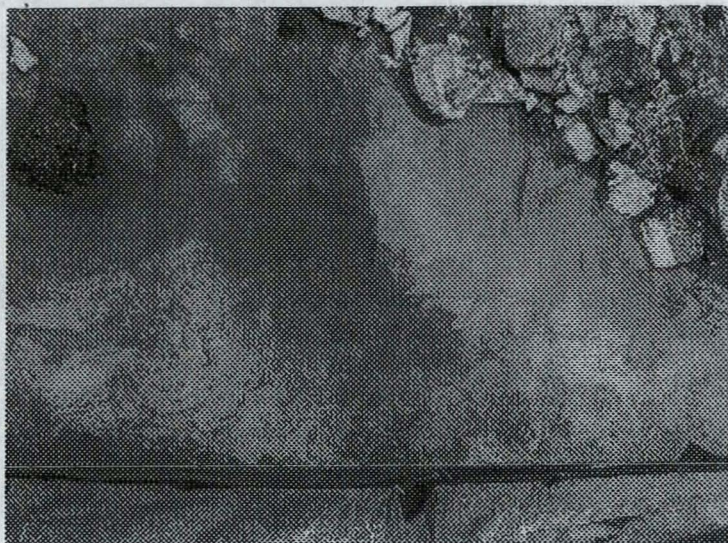
Avery Landing 008.JPG  
09/15/2000  
View of backside of coffer dam  
*Petroleum film evident*

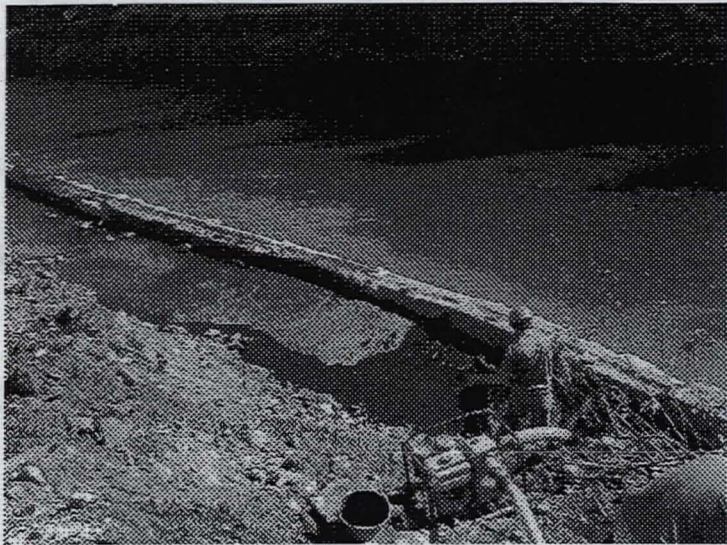
Avery 008.JPG  
09/25/2000

Viewing upriver from W end of site. Lots of petroleum behind coffer dam; some silting outside of dam

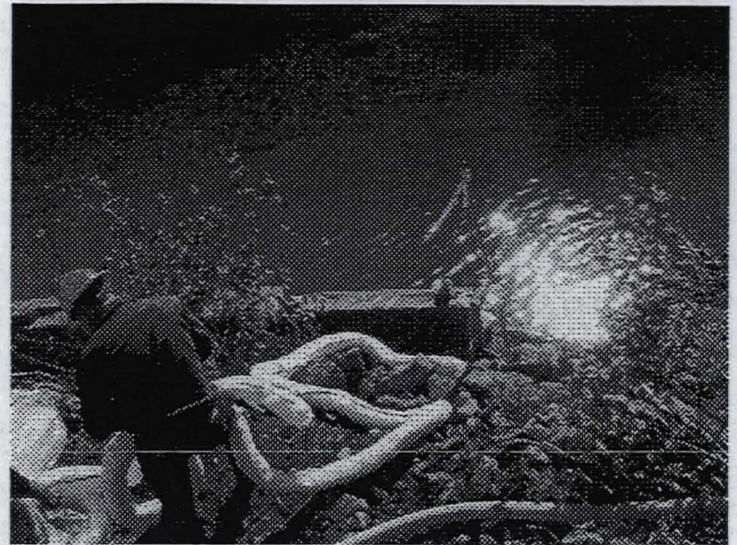
Avery 009.JPG  
09/25/2000

Potlatch workers adding new boom to W end of site where minor amounts of petroleum were escaping thru coffer dam

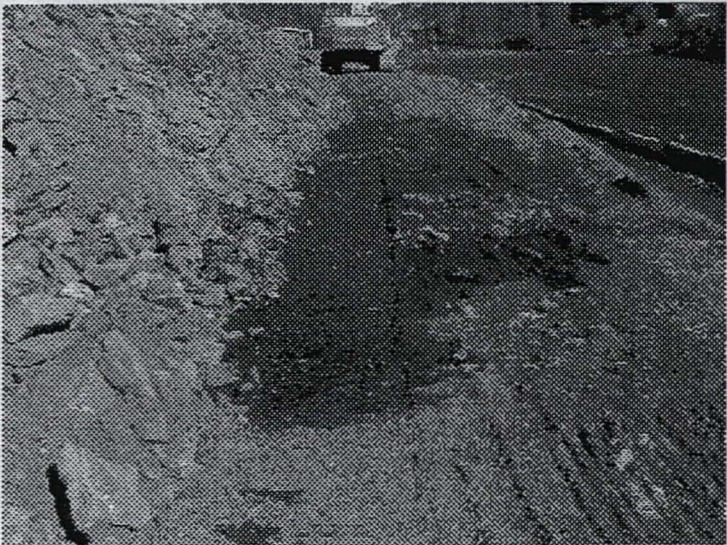
Avery 010.JPG  
09/25/2000

Petroleum seep on bench in approx. center of site. Unknown whether this came from heavy equip or ground

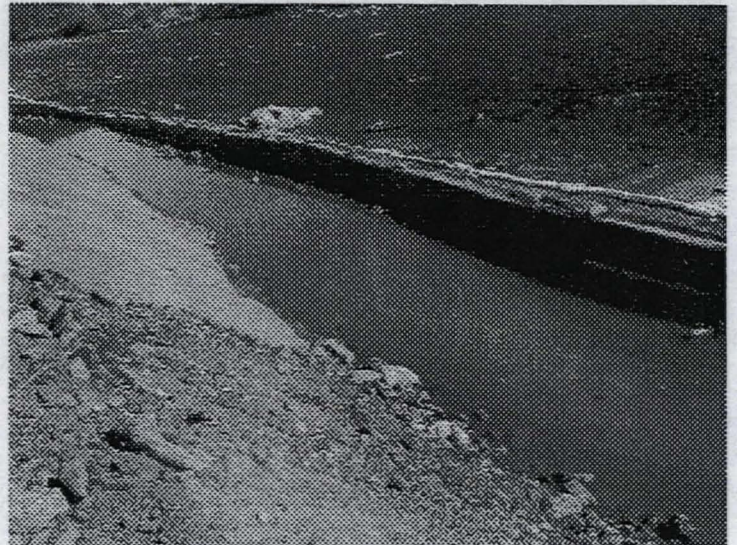
Avery 011.JPG  
09/25/2000

Photo of silt and oil behind coffer dam on W end of site

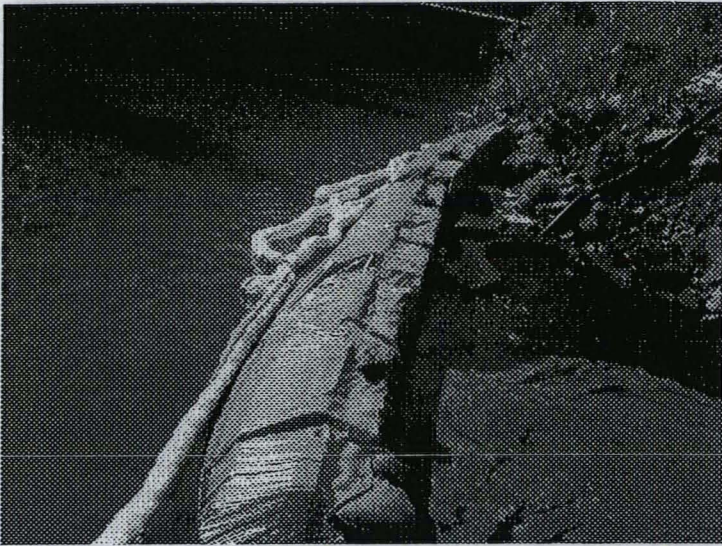
Avery 012.JPG  
09/25/2000

Viewing downstream @ contaminated W end of site, behind coffer dam

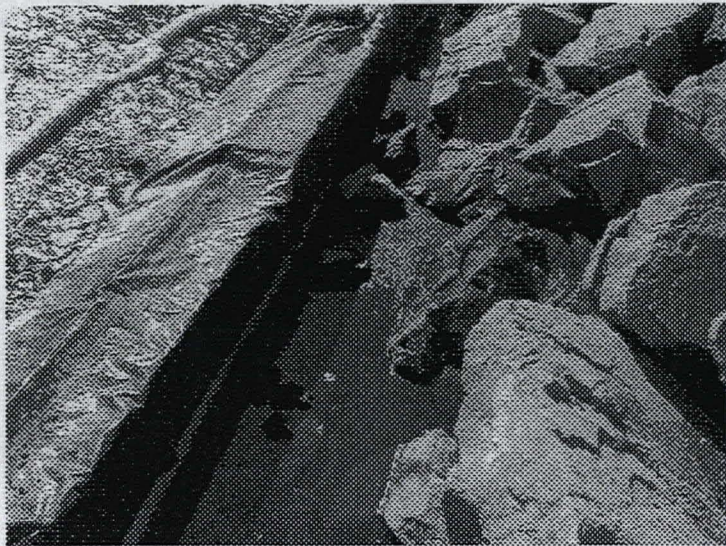
Small area of petroleum scum forming behind coffer dam, about 1/3 of the way downstream from E end of site

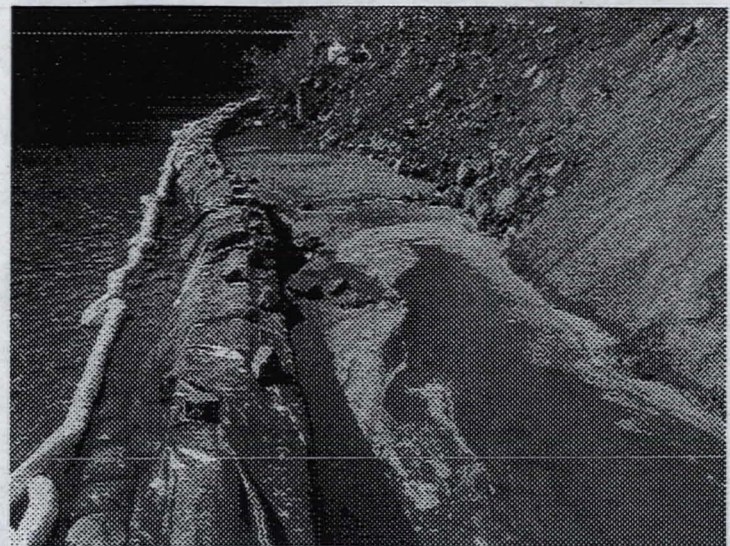
Avery Landing CAP 017.JPG  
09/27/2000  
Photo of petroleum scum buildup on extreme W end of site

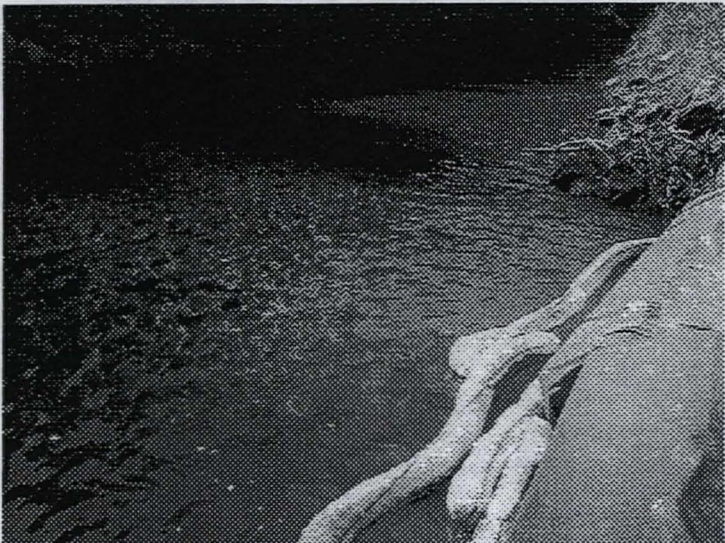
Avery Landing CAP 018.JPG  
09/27/2000  
Photo of river side of coffer dam at W end of site. Some silt but no petroleum was escaping past the dam

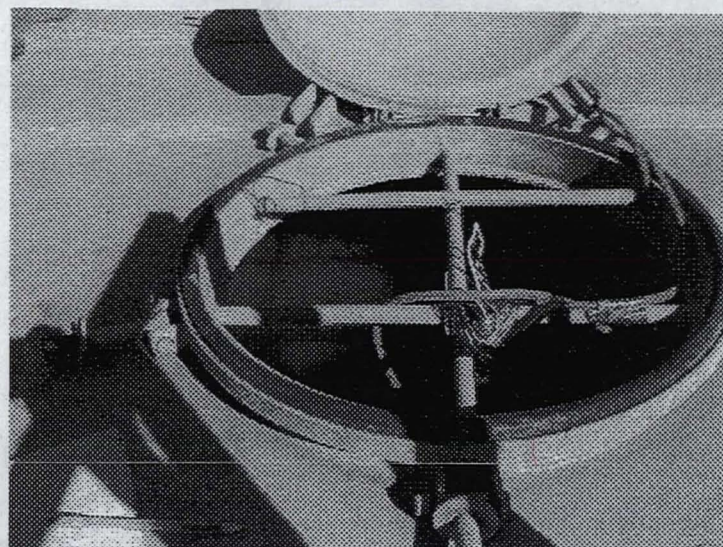
Avery Landing CAP 021.JPG  
09/27/2000

Top entrance to O/W separator. Although not evident, tank was nearly full; very little petroleum film on top of water

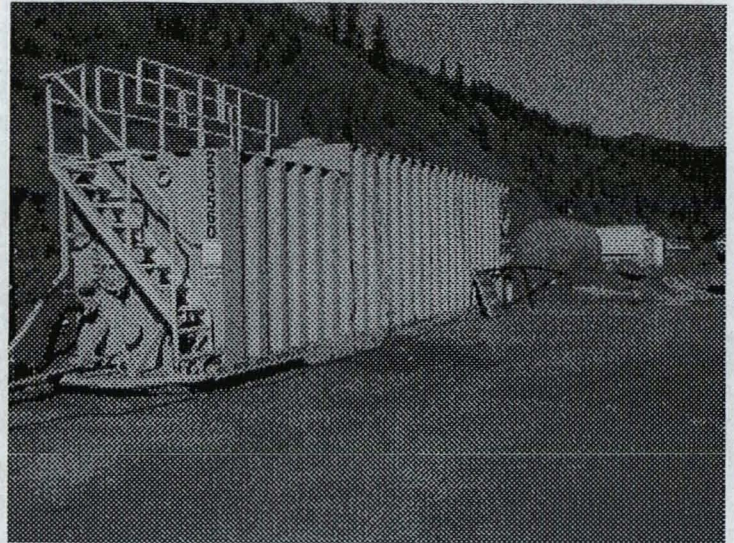
Avery Landing CAP 029.JPG  
09/27/2000  
O/W separator "overtopping". Workers turned on river pump but didn't turn on pump that delivers water to infil. tre
